Surface Analysis Due to Implantoplasty of Failed Dental Implants Using Laser Topography - An Experimental In-Vitro Study

Sahana Selvaganesh¹, Subhasree R.², Thiyaneswar Nessapan³, Abhinav R.P.⁴, Dimple S.⁵

^{1, 2, 3, 4, 5} Department of Implantology, Saveetha Dental College and Hospitals, Saveetha Institute of Medical and Technical Sciences, Saveetha University, Chennai, Tamil Nadu, India.

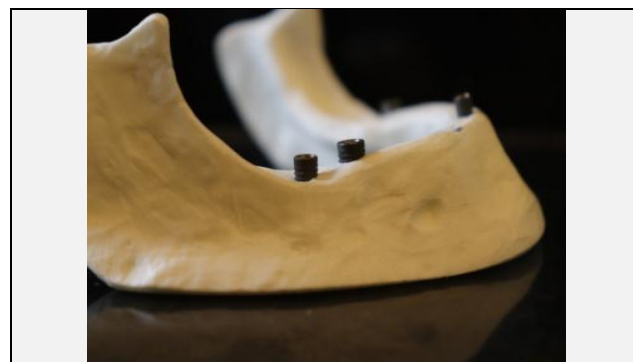
Figure 1. Styrofoam Model with Embedded Implants with 4-5 Threads Exposure

This in-vitro study was conducted in Saveetha Dental College and Hospitals after getting approval from the institutional review board. The implants were procured from the patients whose implants had failed. They were procured over a period of 1 year (Jan 2019 - Jan 2020). In this study, 5 failed implants were taken as the samples and they were randomly allocated under 4 different bur sequences, 1 implant was kept as the control and they were subjected to sterilisation, later these implants were mounted / inserted into the styrofoam model leaving 4 - 5 threads exposed (Fig. 1). A series of dental burs were used in the following sequence of black, green, blue, yellow followed by polishing with a prophylactic paste and polishing buffs. The burs which were selected for this were graded according to the coarseness. Pre-operative radiographs (Fig. 2) and laser topography analysis for each dental implant were done.

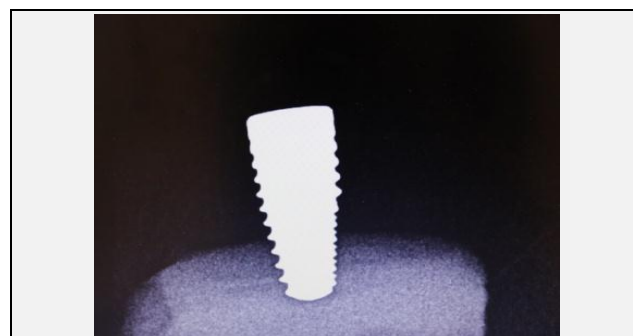
Figure 2. Radiograph of Mounted Implant

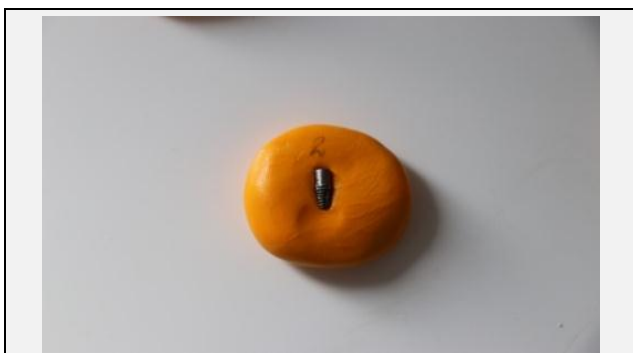
Figure 3. Surface Treated Implant Subjected to Surface Topography Analysis

During the procedure, the operator assessed certain factors such as 1. Amount of titanium dust accumulated on the implant surface, 2. Ease of handling of the instruments and 3. Amount of smoothness according to the operator’s eyes. Later the implantoplasty treated implants were mounted on to the putty index (Fig. 3) and were subjected to laser scanner analysis and the results were noted.

According to the study, the implant 4 turned out to be the smoothest and it was the implant which underwent implantoplasty with burs as well as the prophy paste. The surface scanner analysis with laser also suggested the same. The laser scanner that was used was SD Mechatronik. The vertical sensor resolution is up to 0,8 µm. Thus, fine structures such as cracks and traces of movement can be observed and resolved.

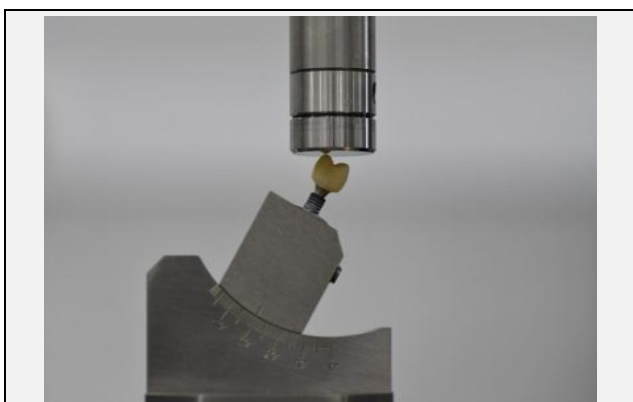
Figure 4. Surface Treated Implant with Crown Tested on Instron Machine

Stock abutments were screwed on to the implants and zirconia crowns were fabricated and the implants were subjected to fracture resistance test under Instron (Fig 4). The strength of the implant abutment complex¹² was tested as implantoplasty involved removing the active threads, and care was taken to prevent the over reduction which could cause damage to the circumference of the implant and also the internal connections in the implant.

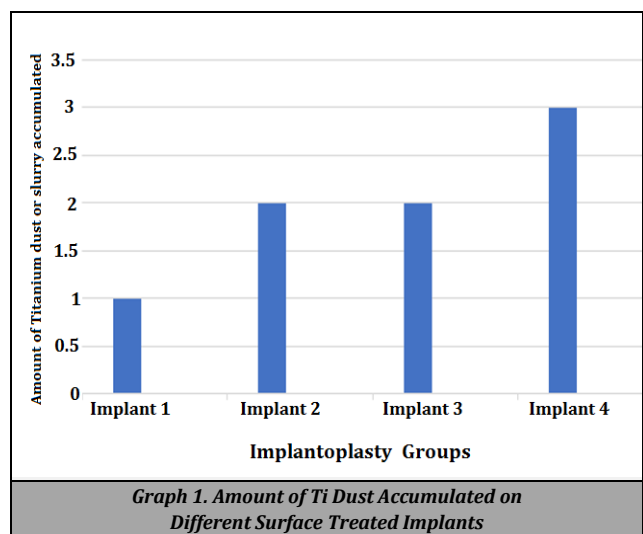
Operator characteristics of amount of dust accumulated on the implant surface were evaluated according to the following - (0 - No amount of dust accumulated, 1 - Minimal amount of dust and slurry accumulated, 2 - Moderate amount of dust and slurry accumulated, 3 - Maximum amount of dust and slurry accumulated.)

- Implant - 1: 1
 - Implant - 2: 2
 - Implant - 3: 2
 - Implant - 4: 3
- Amount of Titanium dust or slurry accumulated.

Graph 1. Amount of Ti Dust Accumulated on Different Surface Treated Implants

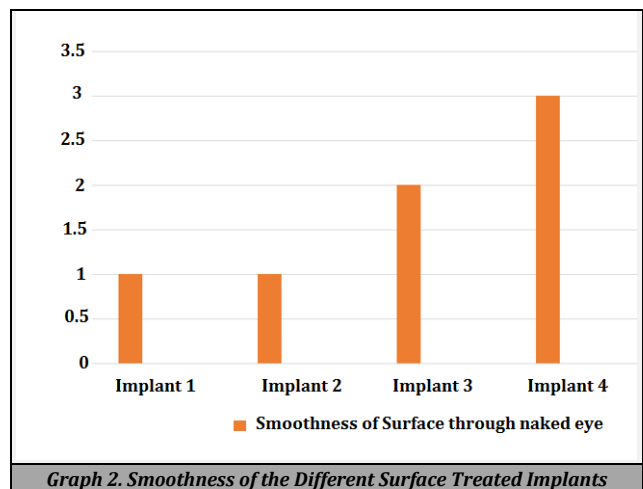
Smoothness of the implant on the naked eye was categorized as follows (1 - surface with harsh marks of the burs, 2 - moderately smooth surface, 3 - completely smooth surface to the naked eye)

- Implant 1: 1
- Implant 2: 1
- Implant 3: 2`
- Implant 4: 3

Graph 2. Smoothness of the Different Surface Treated Implants
